Current Research in Egyptology II

THE AGE OF THE SPHINX AND THE DEVELOPMENT OF THE GIZA NECROPOLIS

Colin Reader

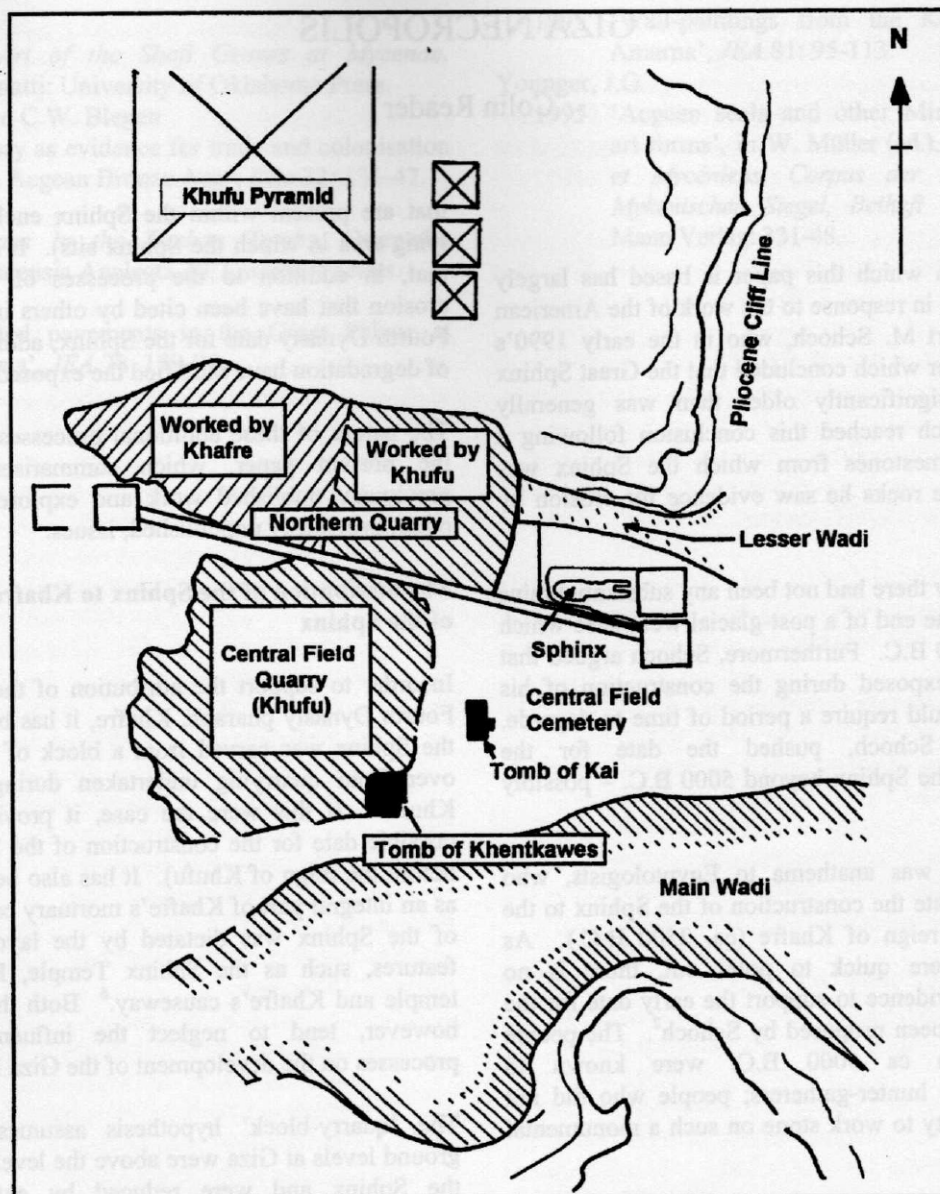
Fig. 1. Sketch plan of the central area of the Giza Necropolis.

Giza Plateau, indicates that this is a naturally eroded feature, which is considered to be the northern bank of a second smaller wadi (the 'Lesser Wadi'— Fig. 1). The presence of this Lesser Wadi has been independently identified by others.⁹

A short distance upslope of the Sphinx enclosure is the eastern limit of a quarry worked, according to Lehner, during the reign of Khufu (Fig. 1).¹⁸ The presence of this quarry can be seen today as a rubble and sand filled depression.

Khafre's causeway was not built from masonry but was actually quarried from *in situ* limestone and, therefore, excavated from the plateau itself. The development of the causeway is, therefore, linked to the quarrying of this area of the plateau. The northern quarry has already been referred to, in relation to the effect of quarrying on run-off and on the age of the Sphinx. Lehner has argued, however, that in order to satisfy demand for stone, Khufu extended quarrying into the Central Field area, to the south of what later became Khafre's causeway (Fig. 1).²²

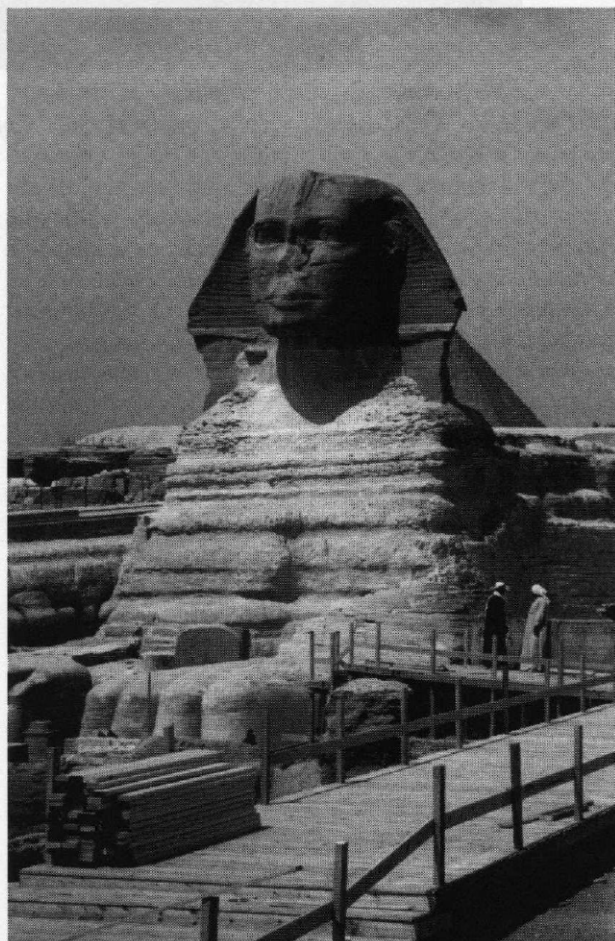
Fig. 2. Degradation of the eastern elevation of the Sphinx. Author's photograph.

Concentrating on the Member II beds, chemical weathering has affected the softer beds to a greater degree than the more durable units. The resulting degradation, as discussed by Gauri¹¹, has taken the form of a pattern of near-horizontal banding, with the more durable beds projecting from the weathered face. This horizontal banding can clearly be seen on the body of the Sphinx (Fig. 2).

The issue of aspect can be readily addressed. The western enclosure walls (Fig. 3) and the chest of the Sphinx (Fig. 2) are exposures with the same aspect, both facing east towards the rising sun. It is evident that, whereas the degradation of the chest of the Sphinx is characterised by features described by Gauri in relation to chemical weathering, the degradation of the western enclosure wall is markedly different.

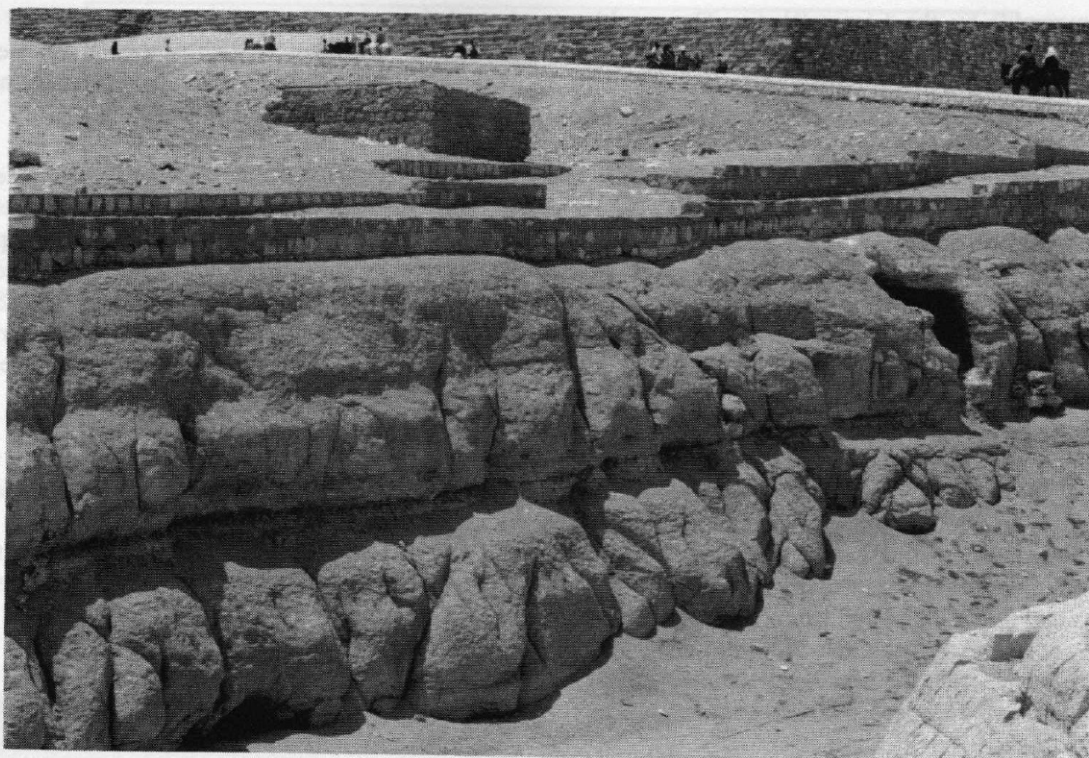
Fig. 3. Degradation of the western wall of the Sphinx enclosure. Author's photograph.

The degradation of the walls in the western end of the Sphinx enclosure has few, if any, parallels within the Giza Necropolis. Furthermore, the processes responsible for this anomalous degradation had, over a scale of tens of metres, a selective or restricted effect on the exposed limestone beds, a characteristic, which is not generally associated with chemical weathering or sand abrasion. It is argued, therefore, that the development of this characteristic degradation requires the action of processes of erosion or weathering in addition to those that have been cited in support of the Fourth Dynasty date for the Sphinx.

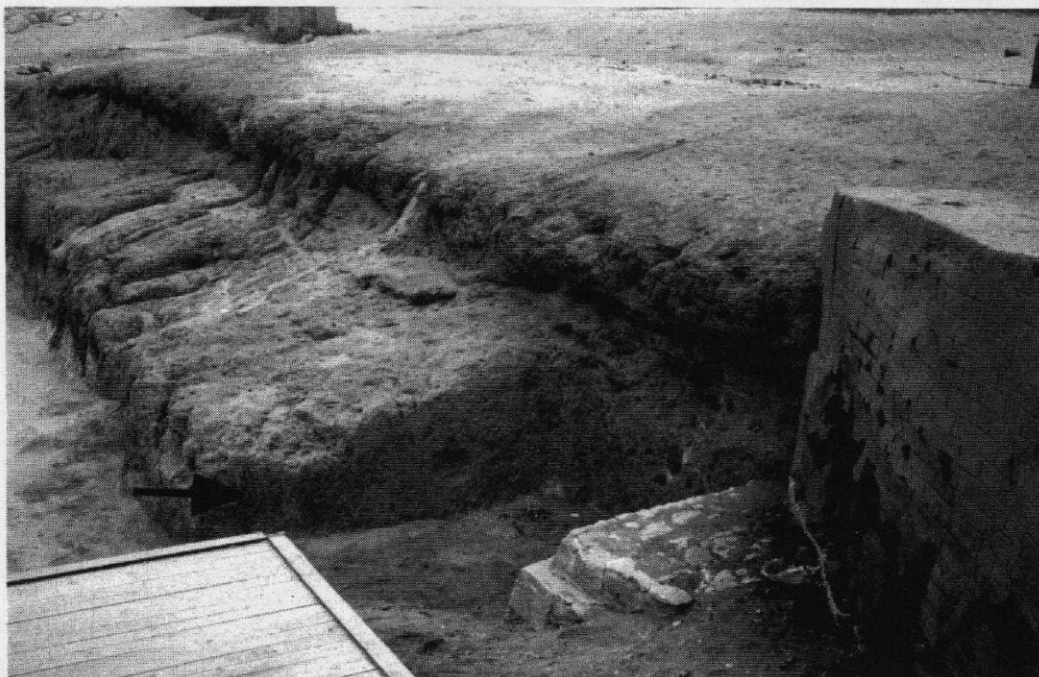
Fig. 4. The western limit (arrowed) of the Fourth Dynasty excavation (foreground) in Member I rocks within the Sphinx enclosure. Note the more heavily degraded Member I strata (background). Author's photograph.

Generally, this cut face exhibits significant degradation, however, at a point opposite the north fore-paw of the Sphinx, there is an abrupt change in the condition of the exposure (Fig. 4). From this position to a point that aligns with the eastern face of the Sphinx Temple, the exposed limestone exhibits comparatively little degradation.

This little-degraded face was cut, according to Lehner¹⁹ in the Fourth Dynasty, probably to facilitate a northward extension of the Sphinx Temple, part of a second phase of Sphinx Temple construction.²⁰ The comparative lack of degradation along this Fourth Dynasty excavation, clearly identifies it as a later cutting into an existing excavated face. The more intense degradation of the limestone beyond this Fourth Dynasty excavation indicates not only the greater age of the original excavation of the Sphinx, but also illustrates the relatively benign influence of post-Fourth Dynasty chemical weathering on these particular Member I beds.

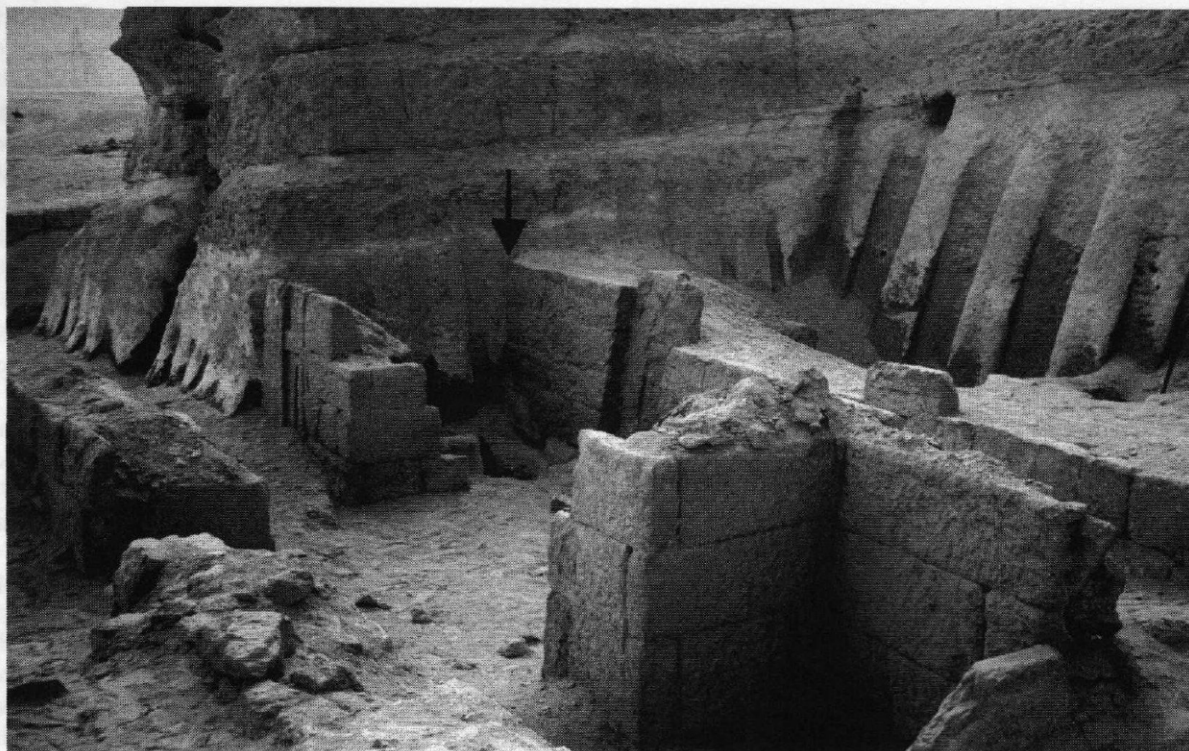
Fig. 5. Tombs, with architecture typical of the Fourth Dynasty at Giza, built against the east-facing façade of the tomb of Kai. At the position arrowed, the niched façade of the tomb of Kai had undergone significant degradation before apparently Old Kingdom tombs were constructed. Author's photograph.

In the case of Kai, the remains of the niched facade extend along the southern and eastern faces of the superstructure, facing both the Main Wadi and the Nile valley itself. When compared with the tomb of Khentkawes, the excavated niches on the eastern face are better preserved, extending to a greater height up the external walls of the tomb. This better preservation can be readily explained; it is the result of protection from degradation provided by a number of tombs constructed against the eastern face of the mastaba.

Unlike the Early Dynastic architectural style represented by the niched façade, these additional tombs are characterised by the austere architectural style adopted throughout the Giza Necropolis in the Fourth Dynasty. An assessment of the eastern face of the mastaba of Kai suggests that the original rock cut tomb, with its niched façade, had been completed and exposed to degradation for some time before the addition of the overlying Old Kingdom construction. In places it can be seen that the niched façade had undergone significant degradation before the Old Kingdom masonry was added (Fig. 5).
