The geomorphological evidence for the Early Dynastic origins of the Great Sphinx of Giza: a response to Drs Lehner and Hawass

Colin D. Reader

Engineering geologist and independent researcher

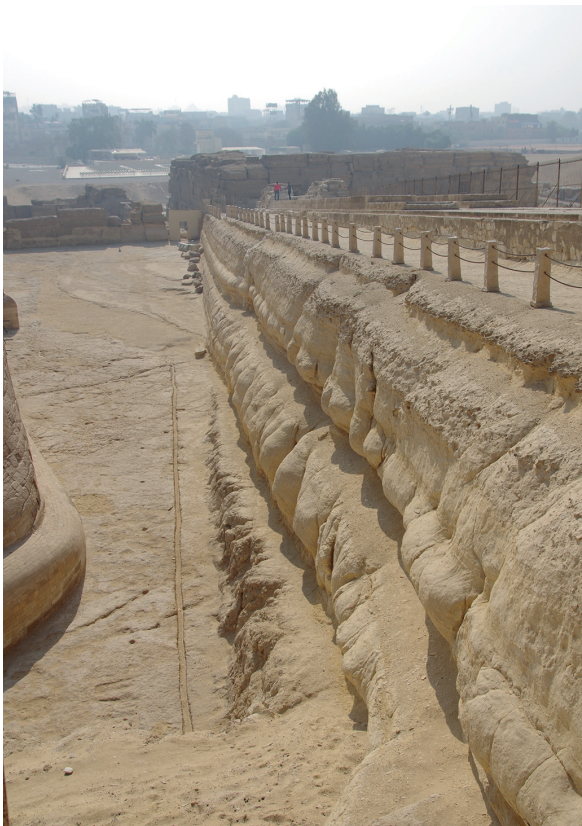
Figure 3: Looking east along the southern wall of the Sphinx enclosure, it is evident that the western end of the enclosure (foreground) has been degraded to a greater extent than the eastern end (background).

Irrespective of when the Great Sphinx was originally excavated, from the outset it will have been subject to a range of processes of weathering and erosion. As explored in detail elsewhere, these processes will have included chemical weathering, the daily heating and cooling of the exposed limestones as the sun rises and sets and abrasion by wind-blown sand. All these processes will have played a role in the degradation of the Great Sphinx, contributing to the form seen today. As previously discussed at length, however (for example Reader 2001), there is one particular feature of the degradation within the Sphinx enclosure that is not consistent with the action of these processes: this is an evident distribution in the intensity of degradation within the Sphinx enclosure, with the rounded, most heavily degraded exposures lying along the western enclosure walls (figs 2 and 3).

As figure 4 shows, the topography of the area surrounding the Sphinx causes the flow lines to draw closer together as they approach the western wall of the enclosure. These close flow lines indicate an increase in flow intensity in this area and correspond with the area of intense degradation along the western enclosure wall. The absence of flow lines at the eastern end of the southern enclosure wall (the area adjacent to the valley temple and Sphinx temple) suggests that only low intensity flow will have reached this area. The pair of widely spaced flow lines intercepting the western end of the southern enclosure wall suggest that flow intensity along this exposure increased towards the west. Once again, the distribution of flow lines along the southern enclosure wall is consistent with the distribution of more intense degradation evident within the Sphinx enclosure (fig. 3).

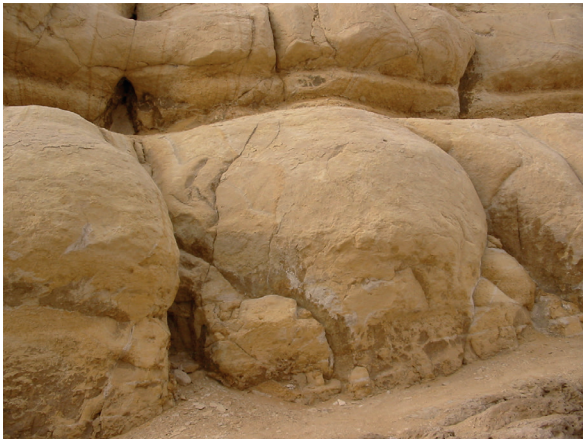
Figure 5: Heavy rounded degradation in the west of the Sphinx enclosure. The exposed limestones are naturally divided into blocks by sets of nearly vertical joints. Deep erosion of the joints by surface run off has led to the development of rounded features such as this example.

As modelled by the flow net presented as figure 4, however, prior to Khufu's quarrying at Giza, high-energy run-off discharging into the Sphinx enclosure, will have scoured the joints and fissures exposed along the western enclosure walls, leading to these discontinuities being cut back deeply into the exposed face. When the deep scouring of the exposed joints was combined with the high-energy erosion of the strata between the discontinuities, this led to the development of the heavily rounded features that are present in the west of the Sphinx enclosure (fig. 5). Despite the presence of numerous joints and fissures exposed along the eastern enclosure walls, localised rounded features such as that shown on figure 5 are not evident in the eastern part of the Sphinx enclosure or along exposed sections of the body of the Sphinx.

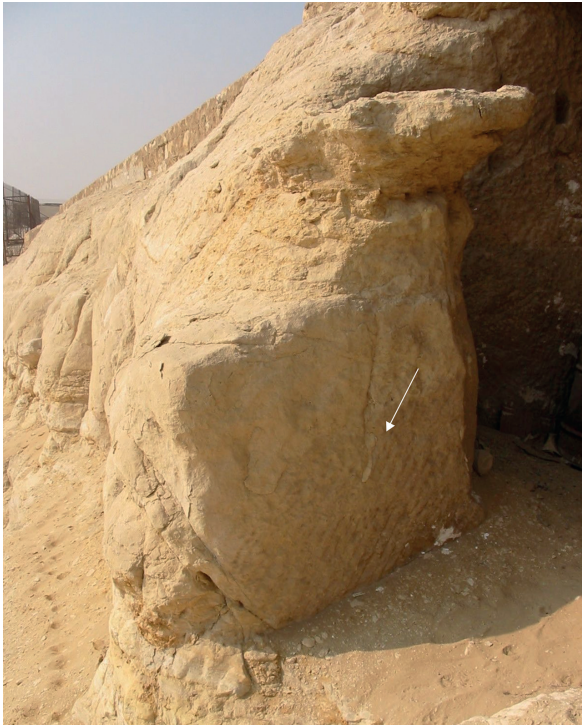
Figure 6: Chisel marks on the entrance to a Late Period tomb excavated into the western Sphinx enclosure wall.

Perhaps most telling, however, is the evidence presented by a series of tombs that have been cut into the western Sphinx enclosure wall. These tombs, which include the 26th Dynasty tomb of Ptahardais (c. 664 to 525 BC; Porter and Moss, 1974: plan VI and p. 291) are some 2,500 years old and once excavated will have had the same frequency and duration of exposure as the adjacent western enclosure wall. According to Lehner and Hawass, the more intense degradation of the western Sphinx enclosure ‘does not require centuries or millennia to have taken place’ and can be expected

to occur over a ‘few generations’ (2017: 60). Lehner and Hawass’ model for the degradation of the Sphinx and Sphinx enclosure, however, does not account for the extensive preservation of ancient tool marks along the rock-cut entrances to these Late Period tombs (fig. 6).

The survival of tool marks on these tomb entrances can be explained in the context of high-energy run-off. Unlike the limestones exposed along the adjacent western wall of the Sphinx enclosure, these Late Period tombs were excavated long after Khufu’s quarrying at the site and have therefore been exposed only to the low-energy run-off that has been experienced since, together with sub-aerial processes including chemical weathering and abrasion by wind-blown sand. Having not been exposed to the more erosive conditions of high-energy run-off that existed before the reign of Khufu, these tomb cuttings are far less heavily degraded when compared with the adjacent walls of the Sphinx enclosure.
